ADDENDUM NO. 1

TO: All Registered Bidders
DATE: April 27, 2022
PROJECT: Little Lake City School District
Jersey Avenue Elementary School Painting and Exterior Building Improvements
CONTACT: Milo Oostinga, Ledesma & Meyer Construction Co., Inc.

LIMITED ASBESTOS INSPECTION REPORT

JERSEY ELEMENTARY SCHOOL
ROOFING AND PAINTING PROJECTS
9400 JERSEY AVENUE
SANTA FE SPRINGS, CALIFORNIA 90670

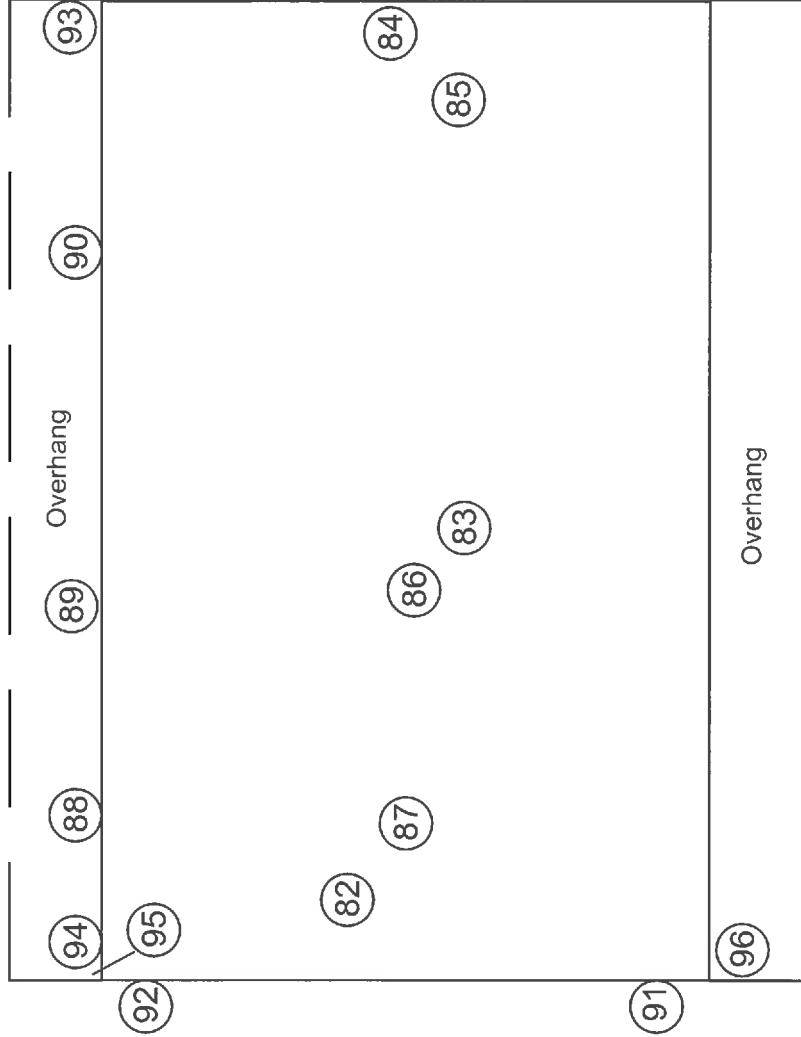
Homogeneous Material #	Material Description	Material Location	Estimated Quantity	Sample Number	Sample Location	Analytical Results
Administration Building						
28	Rolled roofing material (core sample)	Roof top	2,600 Square Feet	1802150029JR-82	North	NAD ^J
				1802150029JR-83	Center	NAD
				1802150029JR-84	South	NAD
29	Roof penetration mastic	Roof top at jacks, HVAC duct base, seams, patches and penetrations	25 Square Feet	1802150029JR-85	South	5% Chrysotile
				1802150029JR-86	Center	5% Chrysotile
				1802150029JR-87	North	8% Chrysotile
30	Window putty	Throughout exterior side of windows	460 Linear Feet	1802150029JR-88	Northeast	NAD
				1802150029JR-89	East	NAD
				1802150029JR-90	Southeast	NAD
31	Brick mortar	Throughout exterior wall	400 Square Feet	1802150029JR-91	Northwest	NAD
				1802150029JR-92	Northeast	NAD
				1802150029JR-93	Southeast	NAD
32	Stucco	East and west overhang	925 Square Feet	1802150029JR-94	Northeast	NAD

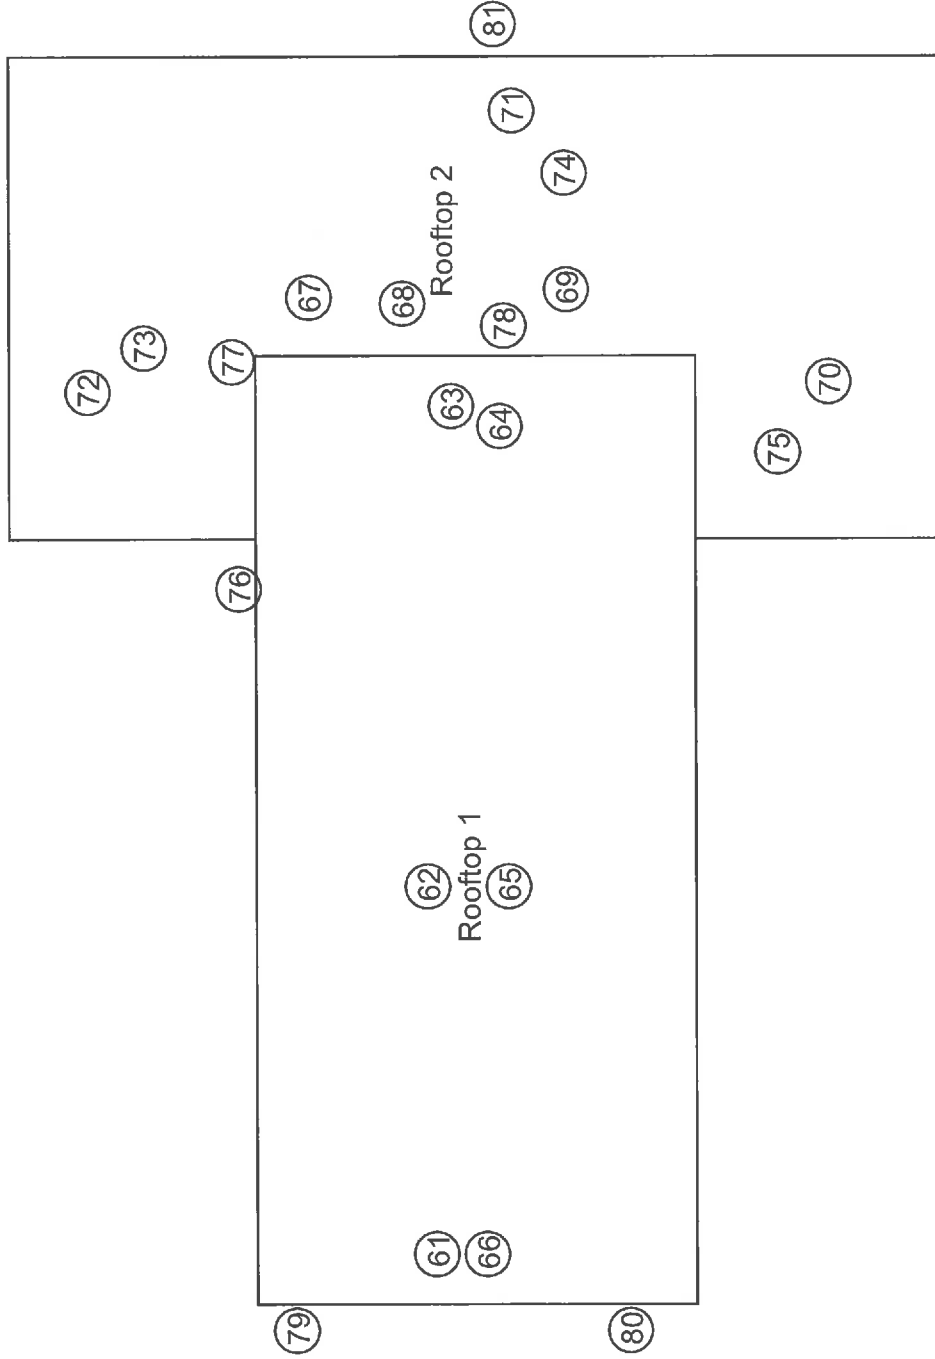
Multi-Purpose Building

Homogeneous Material #	Material Description	Material Location	Estimated Quantity	Sample Number	Sample Location	Analytical Results
Multi-Purpose Building^H						
21	Rolled roofing material (core sample)	Roof top no. 1	3,750 Square Feet	1802150029JR-61	North	NAD ^I
				1802150029JR-62	Center	NAD
				1802150029JR-63	South	NAD
22	Roof penetration mastic	Roof top no. 1 at HVAC duct base, seams, patches and penetrations	50 Square Feet	1802150029JR-64	South	NAD
				1802150029JR-65	Center	NAD
				1802150029JR-66	North	NAD
23	HVAC duct mastic	Roof top no. 2 HVAC ducts	15 Square Feet	1802150029JR-67	Center	NAD
				1802150029JR-68	Center	NAD
				1802150029JR-69	Center	NAD
24	Rolled roofing material (core sample)	Roof top no. 2	3,500 Square Feet	1802150029JR-70	West	NAD
				1802150029JR-71	South	NAD
				1802150029JR-72	East	NAD
25	Roof penetration mastic	Roof top no. 2 at HVAC duct base seams, patches and penetrations	75 Square Feet	1802150029JR-73	East	10% Chrysotile

1802150029JR-74	South	NAD
				1802150029JR-75	West	NAD
26	Stucco	Throughout overhangs and around windows	975 Square Feet	1802150029JR-76	Southeast	NAD
				1802150029JR-77	Southeast	NAD
				1802150029JR-78	South	NAD
27	Brick mortar	Throughout perimeter walls	950 Square Feet	1802150029JR-79	Northeast	NAD
				1802150029JR-80	Northwest	NAD
				1802150029JR-81	South	NAD

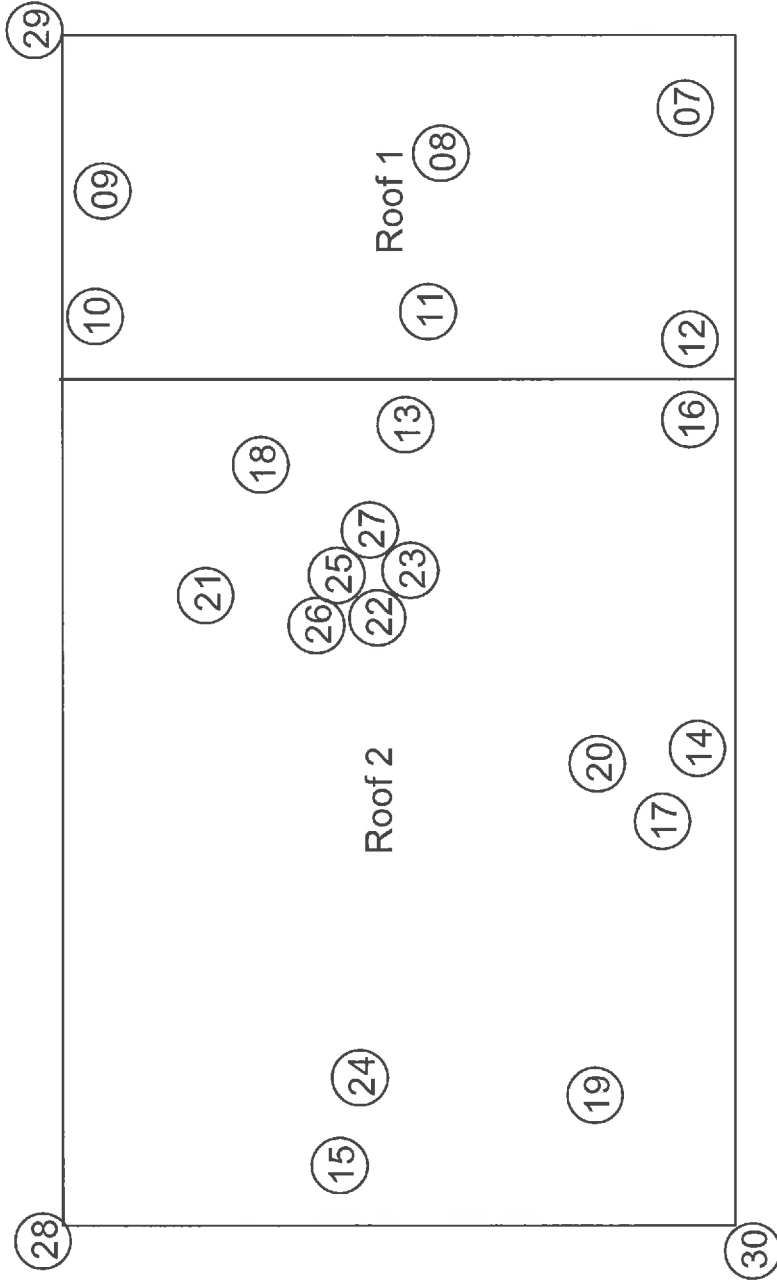
Building IMC/100

Homogeneous Material #	Material Description	Material Location	Estimated Quantity	Sample Number	Sample Location	Analytical Results
Building IMC/100^B						
3	Rolled roofing material (core sample)	Roof top no. 1	500 Square Feet	1802140029JR-07	West	NAD ^C
				1802140029JR-08	Center	NAD
				1802140029JR-09	East	NAD
4	Roof penetration mastic	Roof top no. 1 jacks, seams, patches and penetrations	15 Square Feet	1802140029JR-10	Northeast	NAD
				1802140029JR-11	North	NAD
				1802140029JR-12	Northwest	NAD
5	Rolled roofing material (core sample)	Roof top no. 2	2,550 Square Feet	1802140029JR-13	South	NAD
				1802140029JR-14	West	NAD
				1802140029JR-15	North	NAD
6	Roofing shingles (core sample)	Roof top no. 2	1,550 Square Feet	1802140029JR-16	Southwest	NAD
				1802140029JR-17	West	NAD
				1802140029JR-18	Southeast	NAD
7	Roof penetration mastic	Roof top no. 2 at jacks, seams, patches and penetrations	20 Square Feet	1802140029JR-19	Northwest	NAD

1802140029JR-20	West	NAD
				1802140029JR-21	Southeast	10% Chrysotile
8	Roofing patch coating	Base of HVAC jacks	50 Square Feet	1802140029JR-22	South	NAD
				1802140029JR-23	South	NAD
				1802140029JR-24	North	NAD

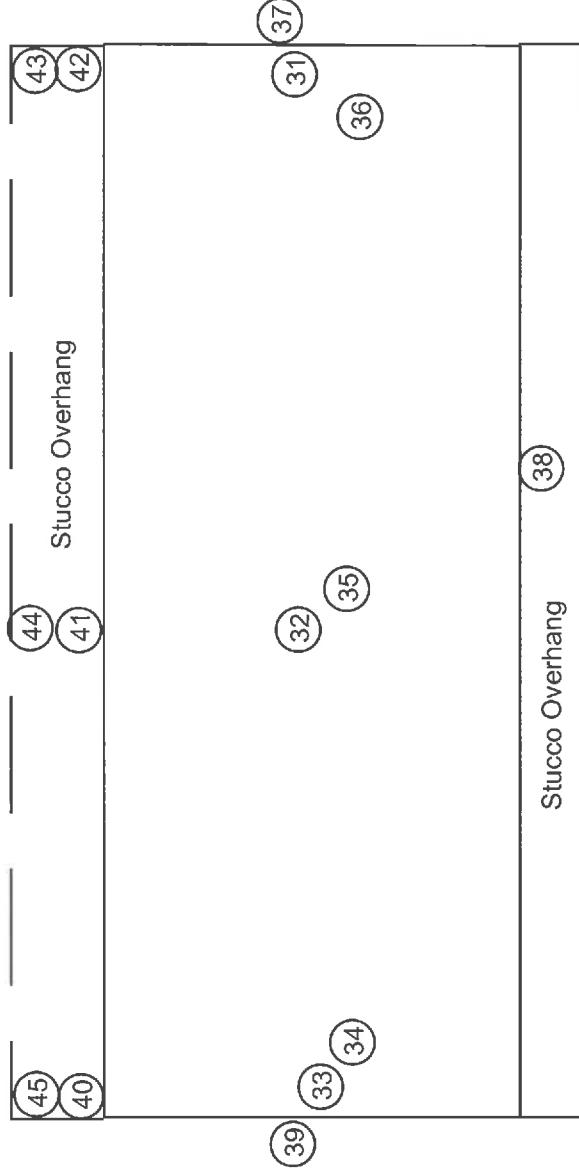
Homogeneous Material #	Material Description	Material Location	Estimated Quantity	Sample Number	Sample Location	Analytical Results
Building 200						
11	Rolled roofing material (core sample)	Roof top	3,400 Square Feet	1802140029JR-31	South	NAD ^E
				1802140029JR-32	Center	NAD
				1802140029JR-33	North	NAD
12	Roof penetration mastic	Roof top at jacks, HVAC duct base seams, patches and penetrations	75 Square Feet	1802140029JR-34	North	10% Chrysotile
				1802140029JR-35	Center	NAD
				1802140029JR-36	South	NAD
13	Window putty	Throughout exterior side of windows	850 Linear Feet	1802140029JR-37	South	NAD
				1802140029JR-38	West	NAD
				1802140029JR-39	North	NAD
14	Brick mortar	Throughout exterior wall	825 Square Feet	1802140029JR-40	Northeast	NAD
				1802140029JR-41	East	NAD
				1802140029JR-42	Southeast	NAD
15	Stucco	East and west overhang	1,000 Square Feet	1802140029JR-43	Southeast	NAD
				1802140029JR-44	East	NAD

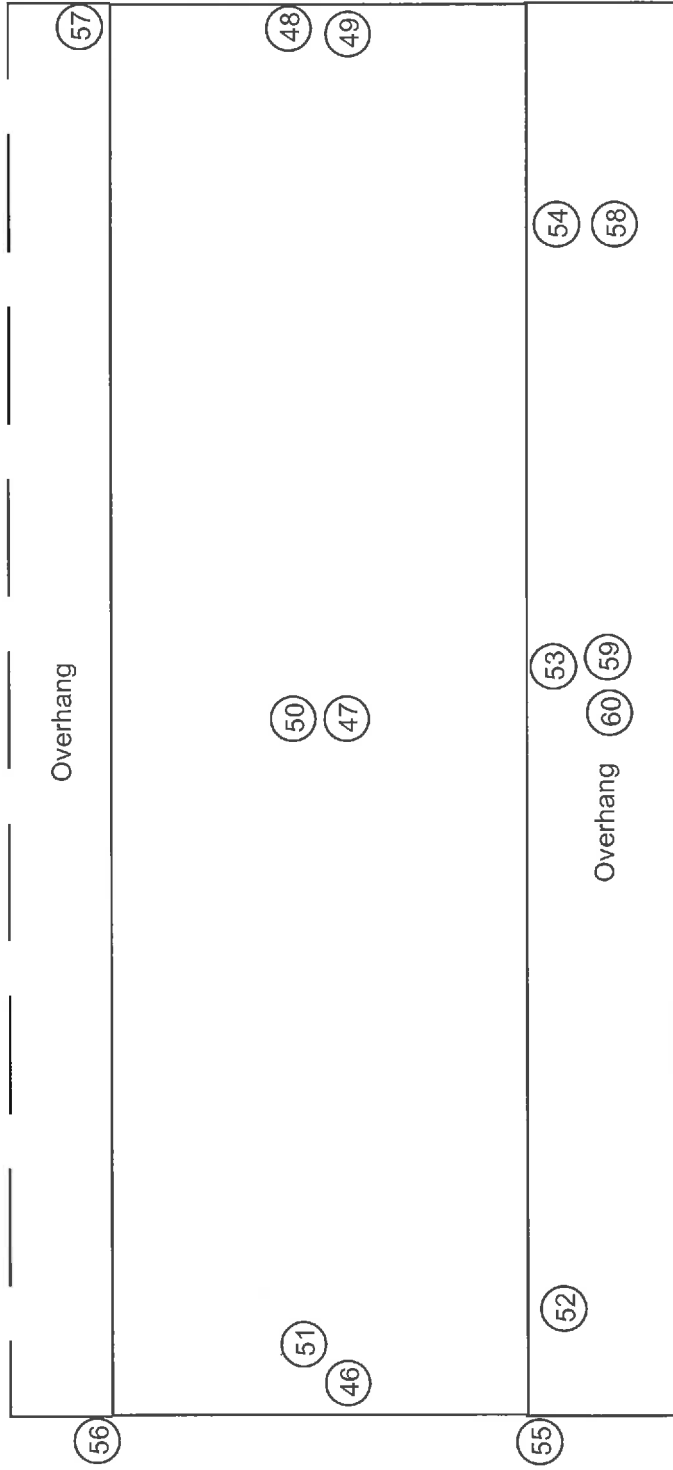
Homogeneous Material #	Material Description	Material Location	Estimated Quantity	Sample Number	Sample Location	Analytical Results
Building 300						
16	Rolled roofing material (core sample)	Roof top	4,900 Square Feet	1802150029JR-46	North	NAD ^F
				1802150029JR-47	Center	NAD
				1802150029JR-48	South	NAD
17	Roof penetration mastic	Roof top at jacks, HVAC duct base, seams, patches and penetrations	100 Square Feet	1802150029JR-49	South	5% Chrysotile
				1802150029JR-50	Center	NAD
				1802150029JR-51	North	NAD
18	Window putty	Throughout exterior side of windows	580 Linear Feet	1802150029JR-52	Northwest	NAD
				1802150029JR-53	West	NAD
				1802150029JR-54	Southwest	NAD
19	Brick mortar	Throughout exterior wall	720 Square Feet	1802150029JR-55	Northwest	<1% Chrysotile ^G
				1802150029JR-56	Northeast	1000-Pt. Ct.: <0.1% chrysotile
				1802150029JR-57	Southeast	NAD
20	Stucco	East and west overhang	950 Square Feet	1802150029JR-58	Southwest	NAD

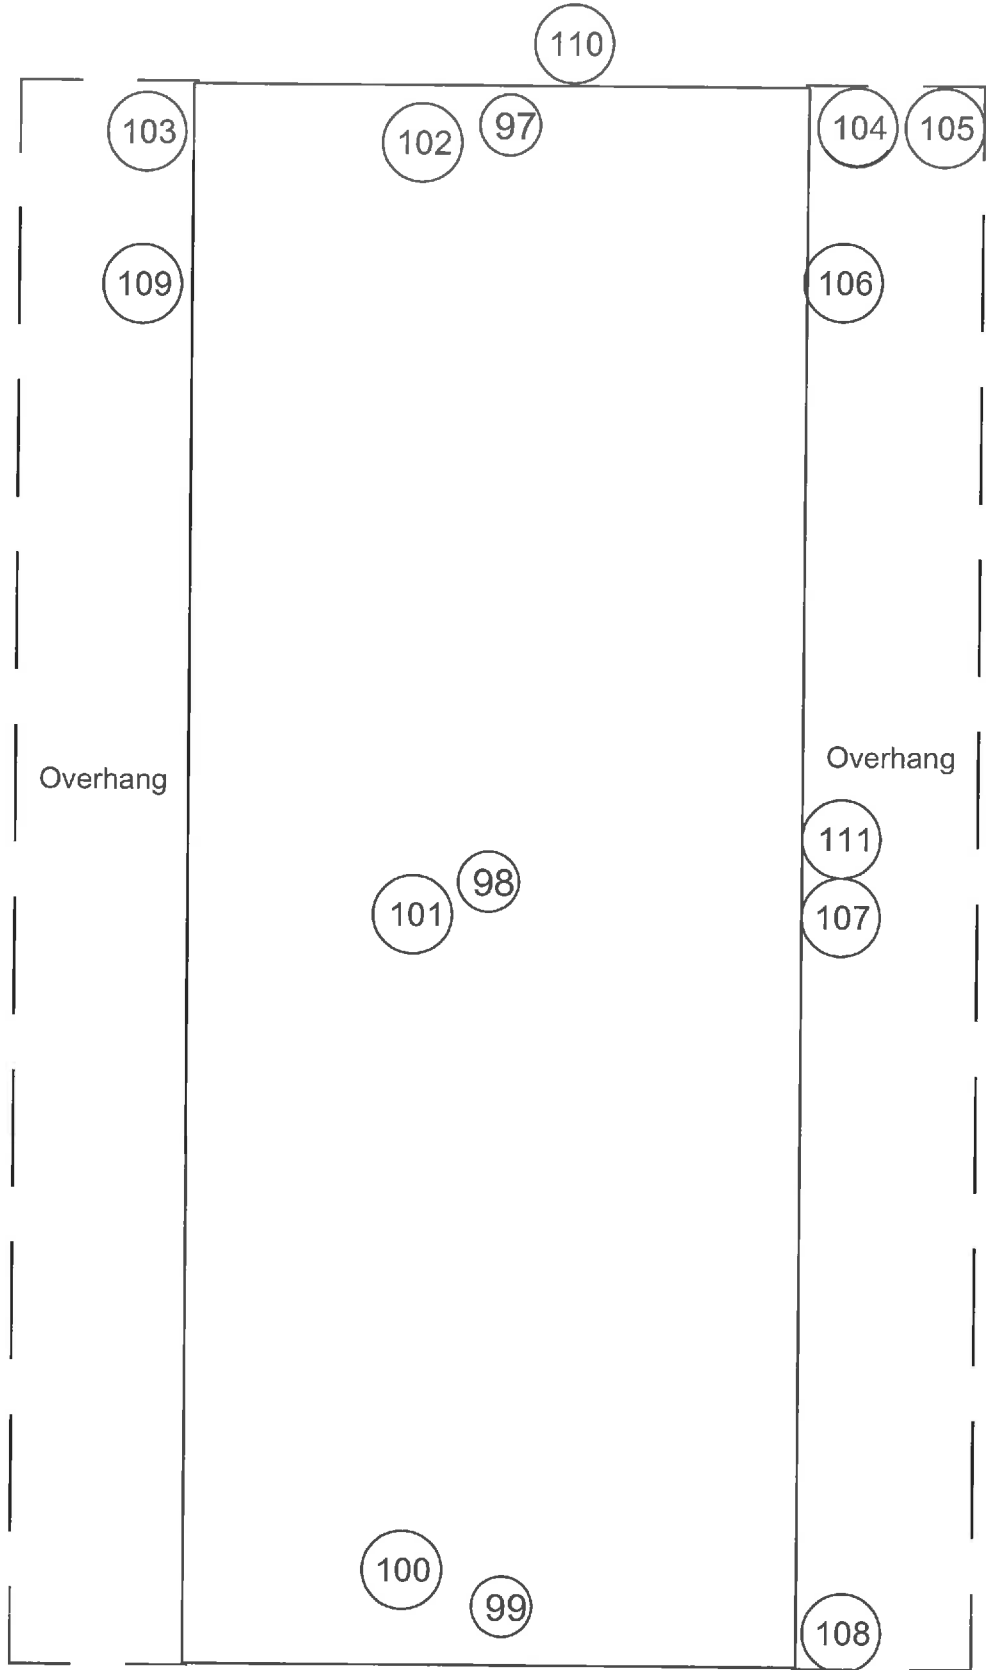
Homogeneous Material #	Material Description	Material Location	Estimated Quantity	Sample Number	Sample Location	Analytical Results
Building 400						
33	Rolled roofing material (core sample)	Roof top	5,900 Square Feet	1802190029JR-97	East	NAD ^k
				1802190029JR-98	Center	NAD
				1802190029JR-99	West	NAD
34	Roof penetration mastic	Roof top at jacks, HVAC duct base, seams, patches and penetrations	120 Square Feet	1802190029JR-100	West	NAD
				1802190029JR-101	Center	NAD
				1802190029JR-102	East	NAD
35	Stucco	North and south overhangs	975 Square Feet	1802190029JR-103	Northeast	NAD
				1802190029JR-104	Southeast	NAD
				1802190029JR-105	Southeast	NAD
36	Window putty	Throughout exterior side of windows	1,200 Linear Feet	1802190029JR-106	Southeast	NAD
				1802190029JR-107	South	NAD
				1802190029JR-108	Southwest	NAD
37	Brick mortar	Throughout exterior wall	750 Square Feet	1802190029JR-109	Northeast	NAD
				1802190029JR-110	East	NAD

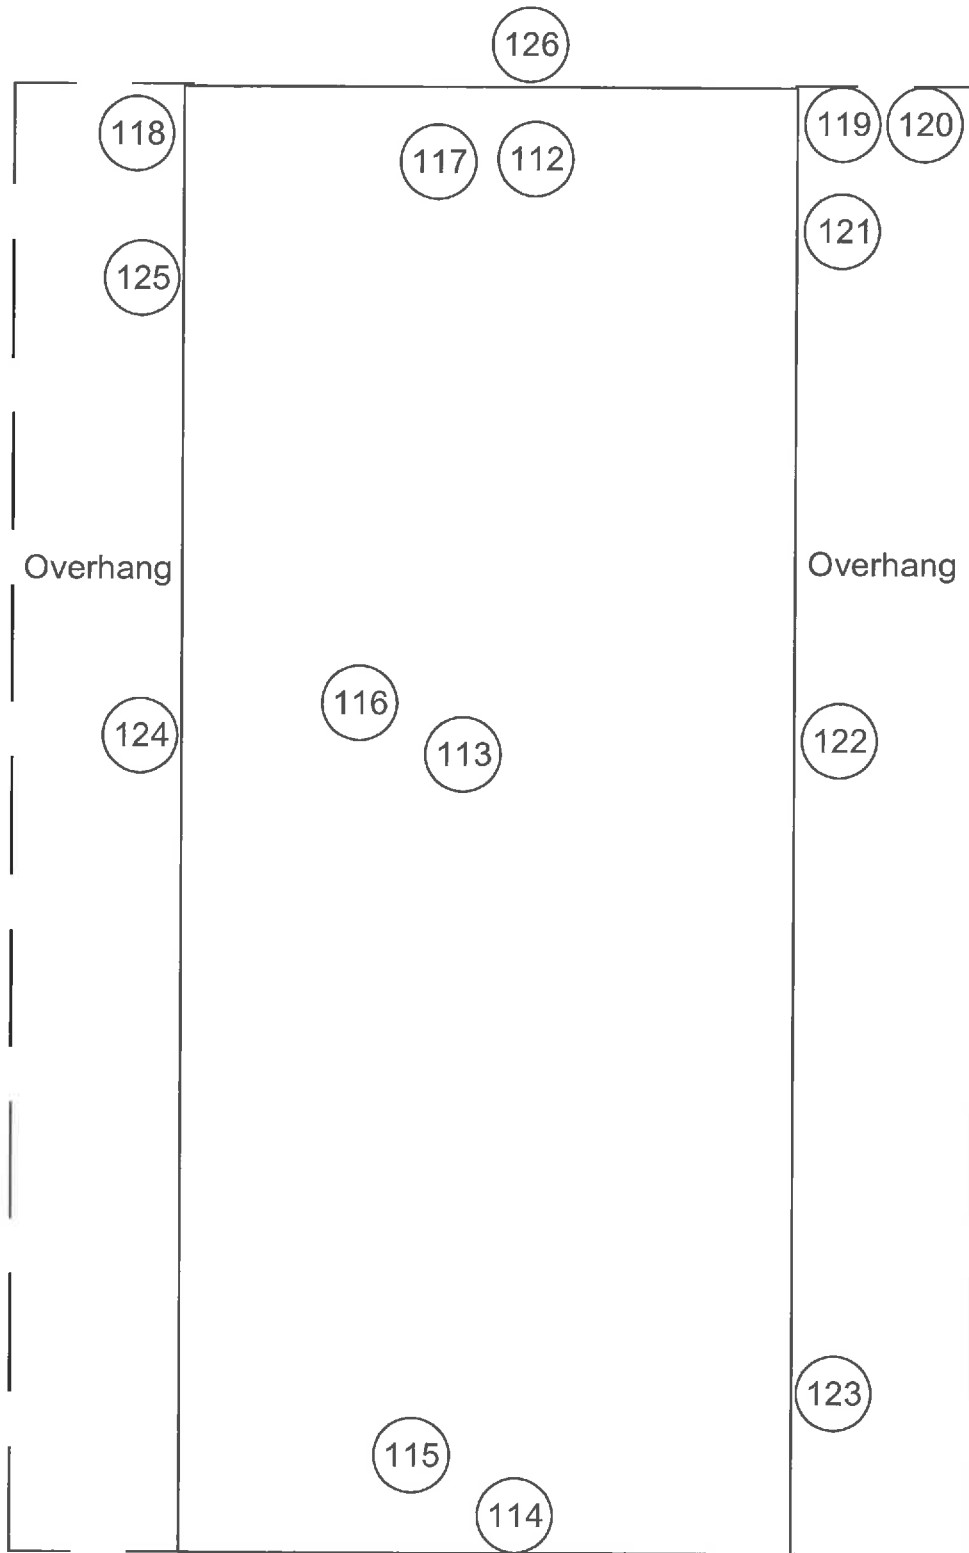
Homogeneous Material #	Material Description	Material Location	Estimated Quantity	Sample Number	Sample Location	Analytical Results
Building 500						
38	Rolled roofing material (core sample)	Roof top	5,700 Square Feet	1802190029JR-112	East	NAD ¹
				1802190029JR-113	Center	NAD
				1802190029JR-114	West	NAD
39	Roof penetration mastic	Roof top at jacks, HVAC duct base, seams, patches and penetrations	120 Square Feet	1802190029JR-115	West	NAD
				1802190029JR-116	Center	NAD
				1802190029JR-117	East	10% Chrysotile
40	Stucco	North and south overhangs	950 Square Feet	1802190029JR-118	Northeast	NAD
				1802190029JR-119	Southeast	NAD
				1802190029JR-120	Southeast	NAD
41	Window putty	Throughout exterior side of windows	1,000 Linear Feet	1802190029JR-121	Southeast	NAD
				1802190029JR-122	South	NAD
				1802190029JR-123	Southwest	NAD
42	Brick mortar	Throughout exterior wall	700 Square Feet	1802190029JR-124	North	NAD

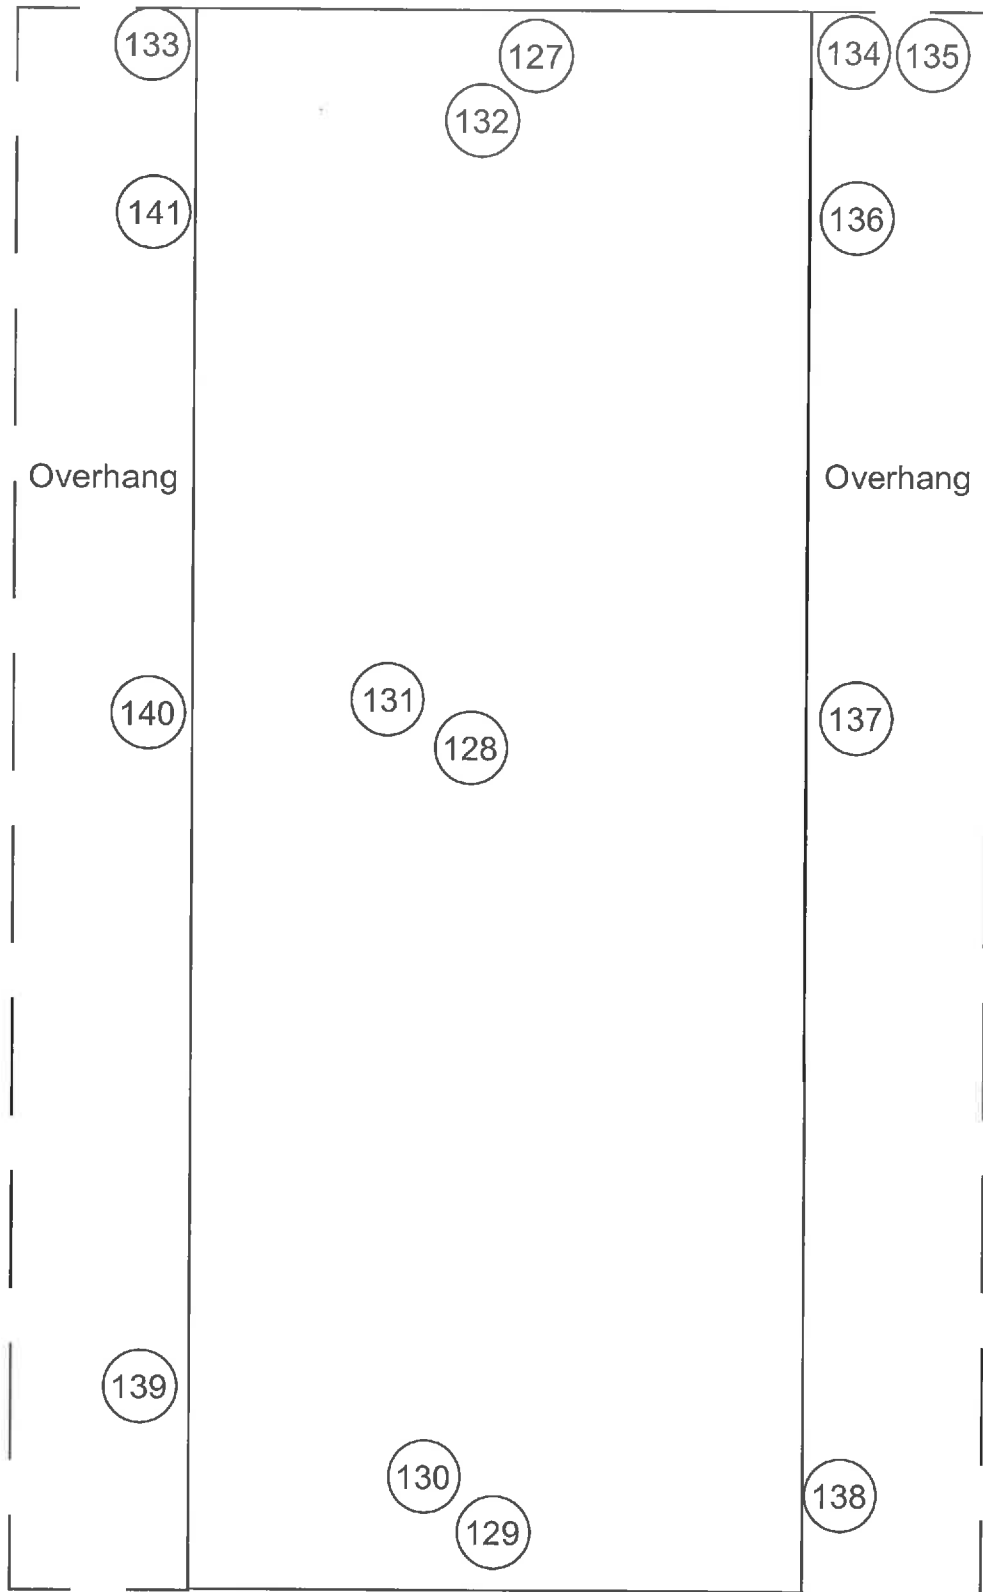
Homogeneous Material #	Material Description	Material Location	Estimated Quantity	Sample Number	Sample Location	Analytical Results
Building 600						
43	Rolled roofing material (core sample)	Roof top	5,900 Square Feet	1802190029JR-127	East	NAD ^M
				1802190029JR-128	Center	NAD
				1802190029JR-129	West	NAD
44	Roof penetration mastic	Roof top at jacks, HVAC duct base seams, patches and penetrations	120 Square Feet	1802190029JR-130	West	10% Chrysotile
				1802190029JR-131	Center	NAD
				1802190029JR-132	East	10% Chrysotile
45	Stucco	North and south overhangs	975 Square Feet	1802190029JR-133	Northeast	NAD
				1802190029JR-134	Southeast	NAD
				1802190029JR-135	Southeast	NAD
46	Window putty	Throughout exterior side of windows	1,200 Linear Feet	1802190029JR-136	Southeast	NAD
				1802190029JR-137	South	NAD
				1802190029JR-138	Southwest	NAD
47	Brick mortar	Throughout exterior wall	750 Square Feet	1802190029JR-139	Northwest	<1% Chrysotile ^N

1000-Pt. Ct.: <0.1% chrysotile
				1802190029JR-140	North	<1% Chrysotile
						1000-Pt. Ct.: <0.1% chrysotile
				1802150029JR-141	Northeast	<1% Chrysotile
						1000-Pt. Ct.: <0.1% chrysotile

^N Samples 139 thru 141 that had a result of less than 1% chrysotile via PLM analysis were further analyzed via the 1000-point count gravimetric method. The analysis by 1000-point count analysis revealed that under Cal/OSHA regulations the brick mortar is a non-regulated material.

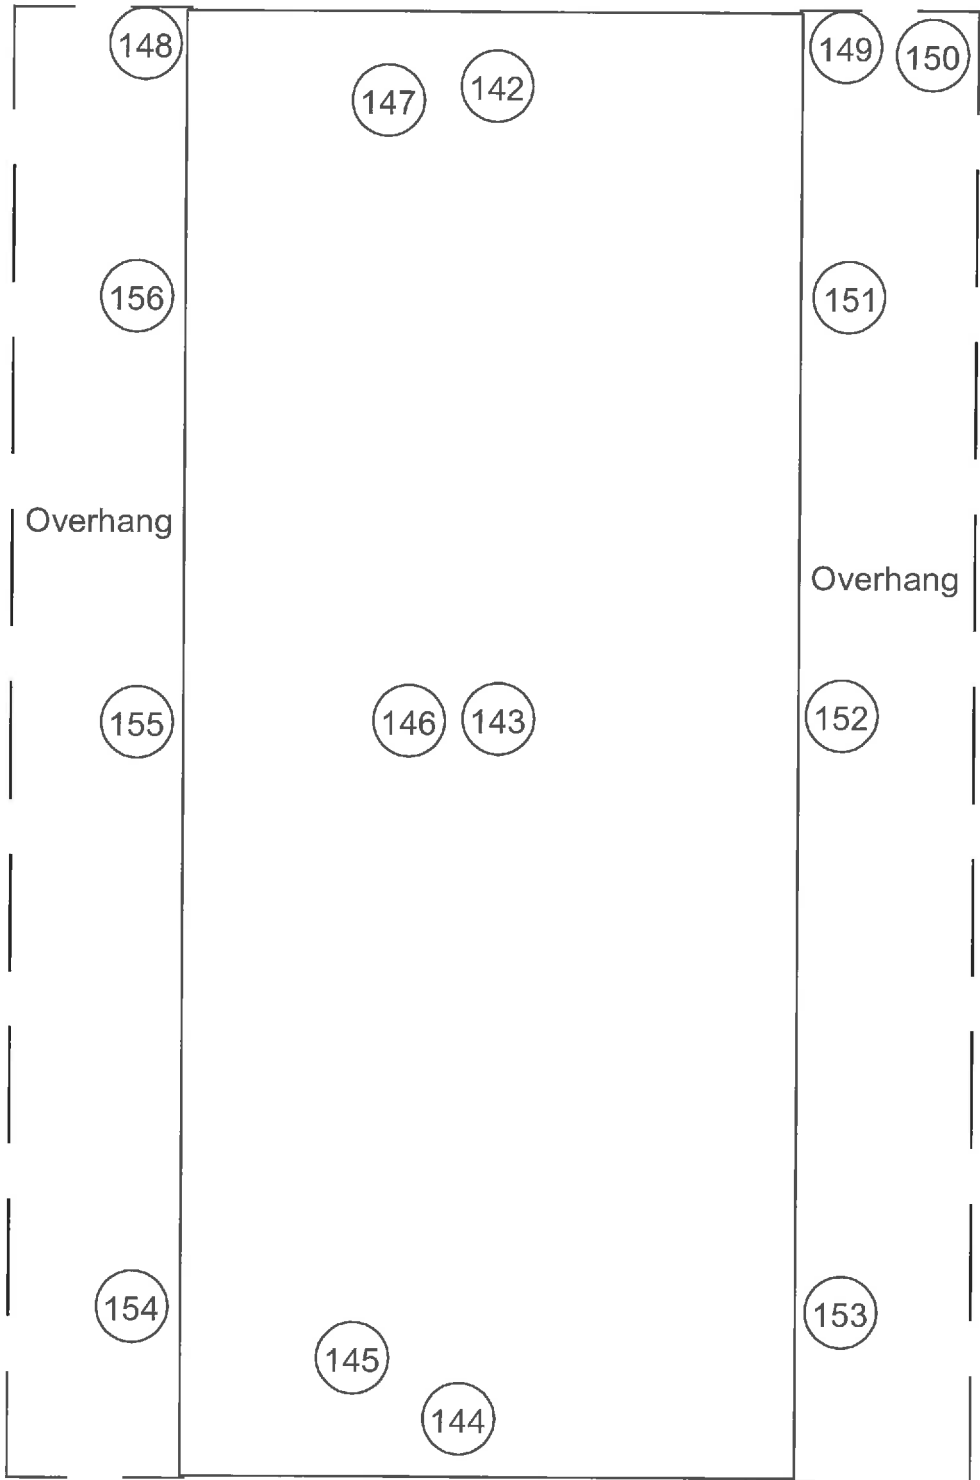
Homogeneous Material #	Material Description	Material Location	Estimated Quantity	Sample Number	Sample Location	Analytical Results
Building 700						
48	Rolled roofing material (core sample)	Roof top	5,700 Square Feet	1802190029JR-142	East	NAD ^o
				1802190029JR-143	Center	NAD
				1802190029JR-144	West	NAD
49	Roof penetration mastic	Roof top at jacks, HVAC duct base, seams, patches and penetrations	120 Square Feet	1802190029JR-145	West	10% Chrysotile
				1802190029JR-146	Center	10% Chrysotile
				1802190029JR-147	East	NAD
50	Stucco	North and south overhangs	950 Square Feet	1802190029JR-148	Northeast	NAD
				1802190029JR-149	Southeast	NAD
				1802190029JR-150	Southeast	NAD
51	Window putty	Throughout exterior side of windows	1,000 Linear Feet	1802190029JR-151	Southeast	NAD
				1802190029JR-152	South	NAD
				1802190029JR-153	Southwest	NAD
52	Brick mortar	Throughout exterior wall	700 Square Feet	1802190029JR-154	Northwest	NAD

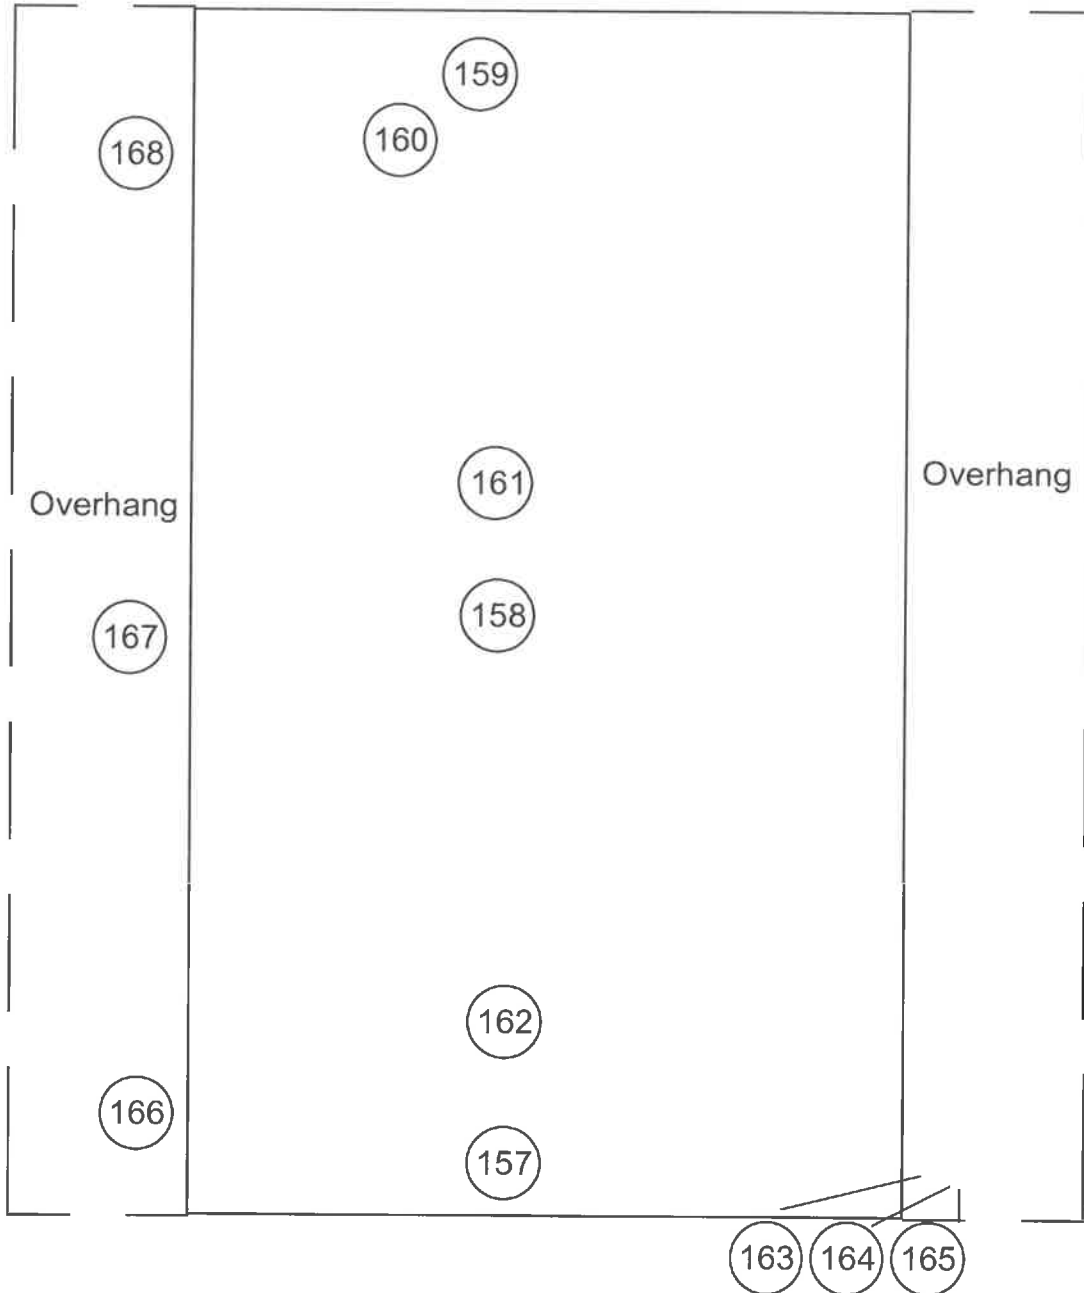
Building 800

Homogeneous Material #	Material Description	Material Location	Estimated Quantity	Sample Number	Sample Location	Analytical Results
Building 800^P						
53	Rolled roofing material (core sample)	Roof top	2,800 Square Feet	1802200029JR-157	West	NAD ^Q
				1802200029JR-158	Center	NAD
				1802200029JR-159	East	NAD
54	Roof penetration mastic	Roof top at jacks, HVAC duct base seams, patches and penetrations	50 Square Feet	1802200029JR-160	East	NAD
				1802200029JR-161	Center	NAD
				1802200029JR-162	West	NAD
55	Stucco	North and south overhangs	650 Square Feet	1802200029JR-163	Southwest	NAD
				1802200029JR-164	Southwest	NAD
				1802200029JR-165	Southwest	NAD
56	Brick mortar	Throughout exterior wall	550 Square Feet	1802200029JR-166	Northwest	NAD
				1802200029JR-167	North	NAD
				1802200029JR-168	Northeast	NAD

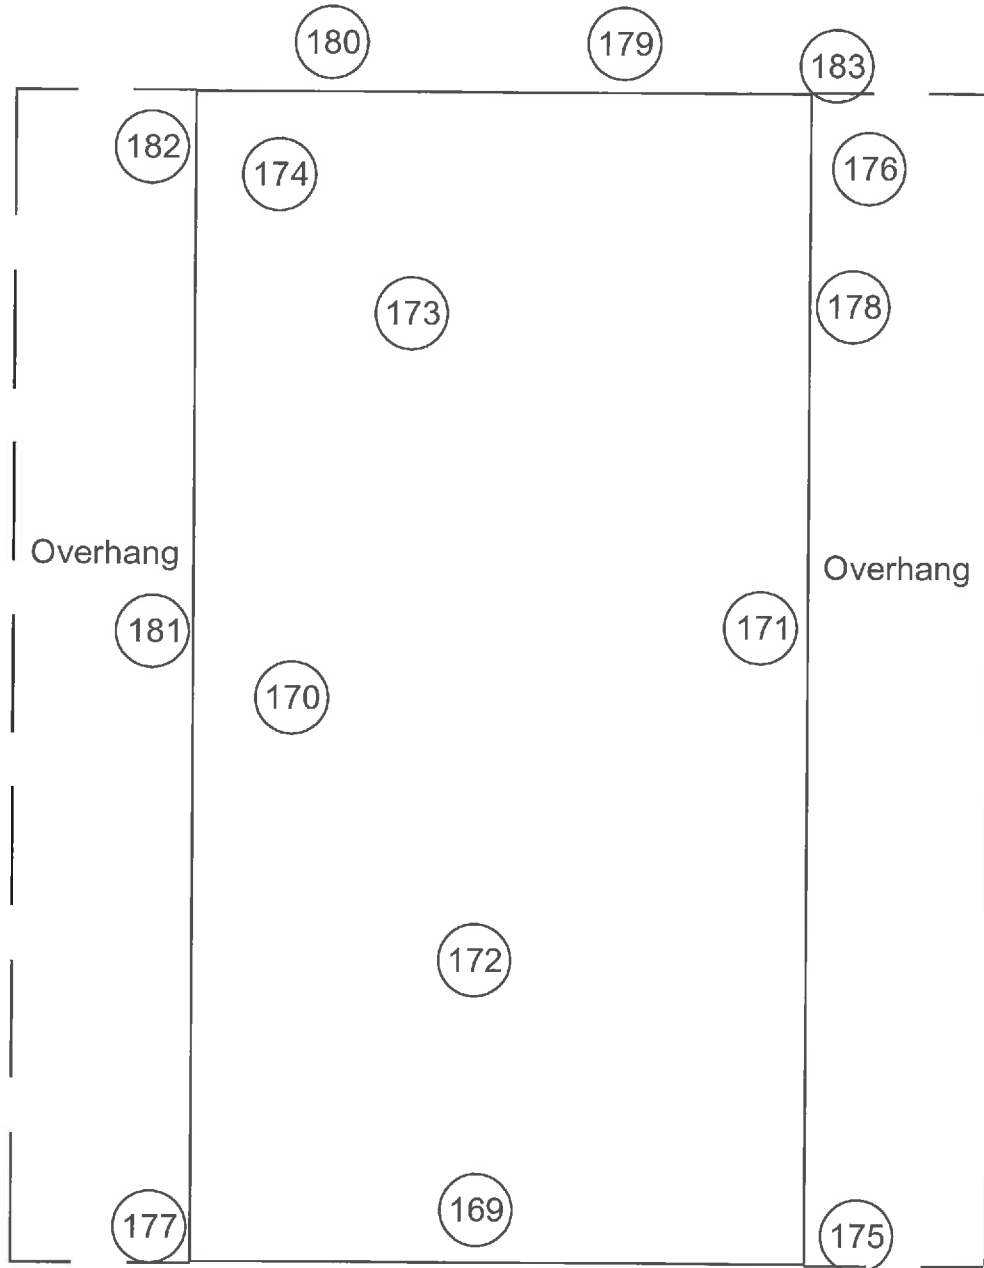
Building 900

Homogeneous Material #	Material Description	Material Location	Estimated Quantity	Sample Number	Sample Location	Analytical Results
Building 900^R						
57	Rolled roofing material (core sample)	Roof top	3,000 Square Feet	1802200029JR-169	West	NAD ^s
				1802200029JR-170	North	NAD
				1802200029JR-171	South	NAD
58	Roof penetration mastic	Roof top at jacks, HVAC duct base seams, patches and penetrations	60 Square Feet	1802200029JR-172	West	NAD
				1802200029JR-173	East	5% Chrysotile
				1802200029JR-174	Northeast	NAD
59	Stucco	North and south overhangs	750 Square Feet	1802200029JR-175	Southwest	NAD
				1802200029JR-176	Southeast	NAD
				1802200029JR-177	Northwest	NAD
60	Caulking sealant	Southeast and east wall vents	30 Linear Feet	1802200029JR-178	Southeast	2% Chrysotile
				1802200029JR-179	East	2% Chrysotile
				1802200029JR-180	Northeast	2% Chrysotile
61	Brick mortar	Throughout exterior wall	600 Square Feet	1802200029JR-181	North	NAD
